# HASANSHAM INTER-AGENCY ASSESSMENT REPORT

NOV 2023

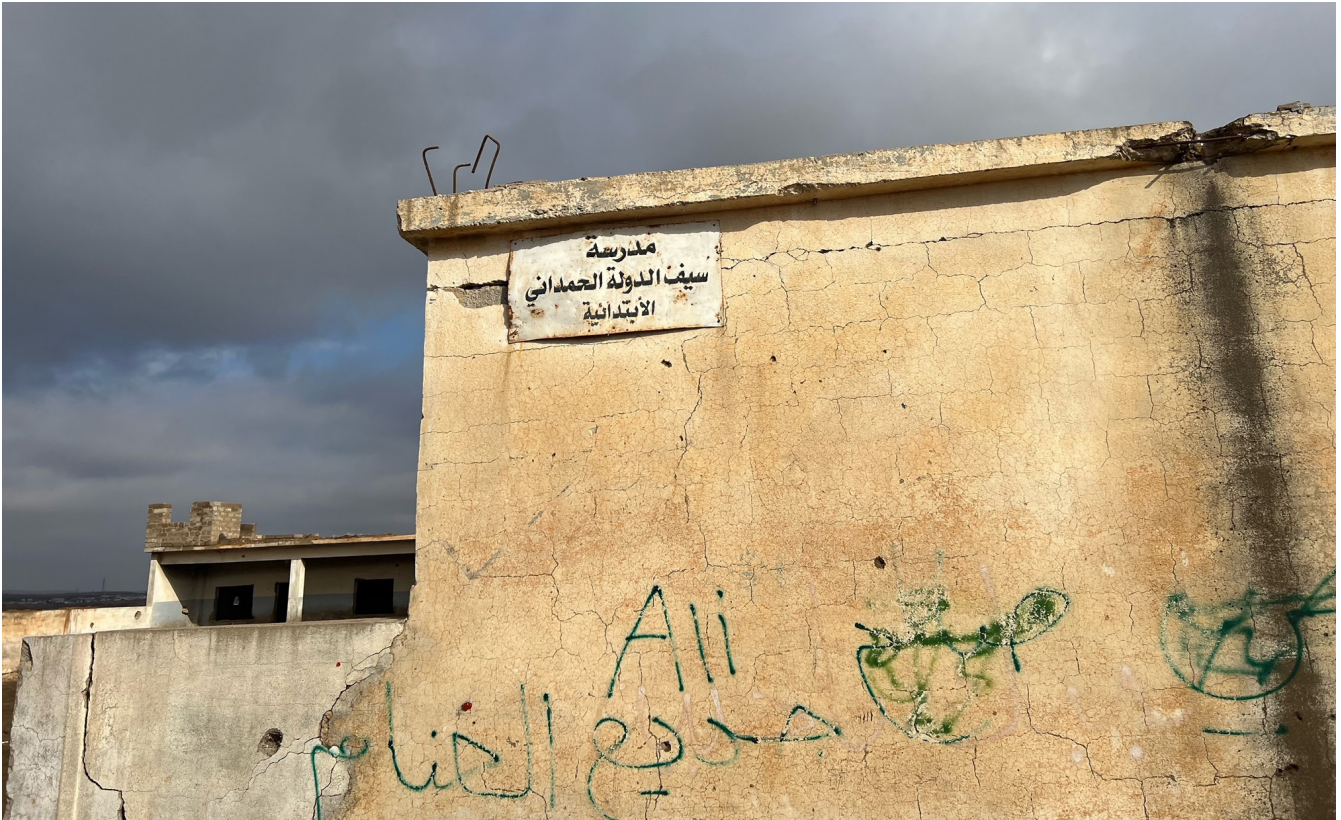
Figure 1: Aliyawa Primary School

The village has two schools.<sup>4</sup> Both school buildings have incurred damage and are currently not functioning and need rehabilitation. UNDP estimates that repairs to the 8-classroom school may cost \$125,000.

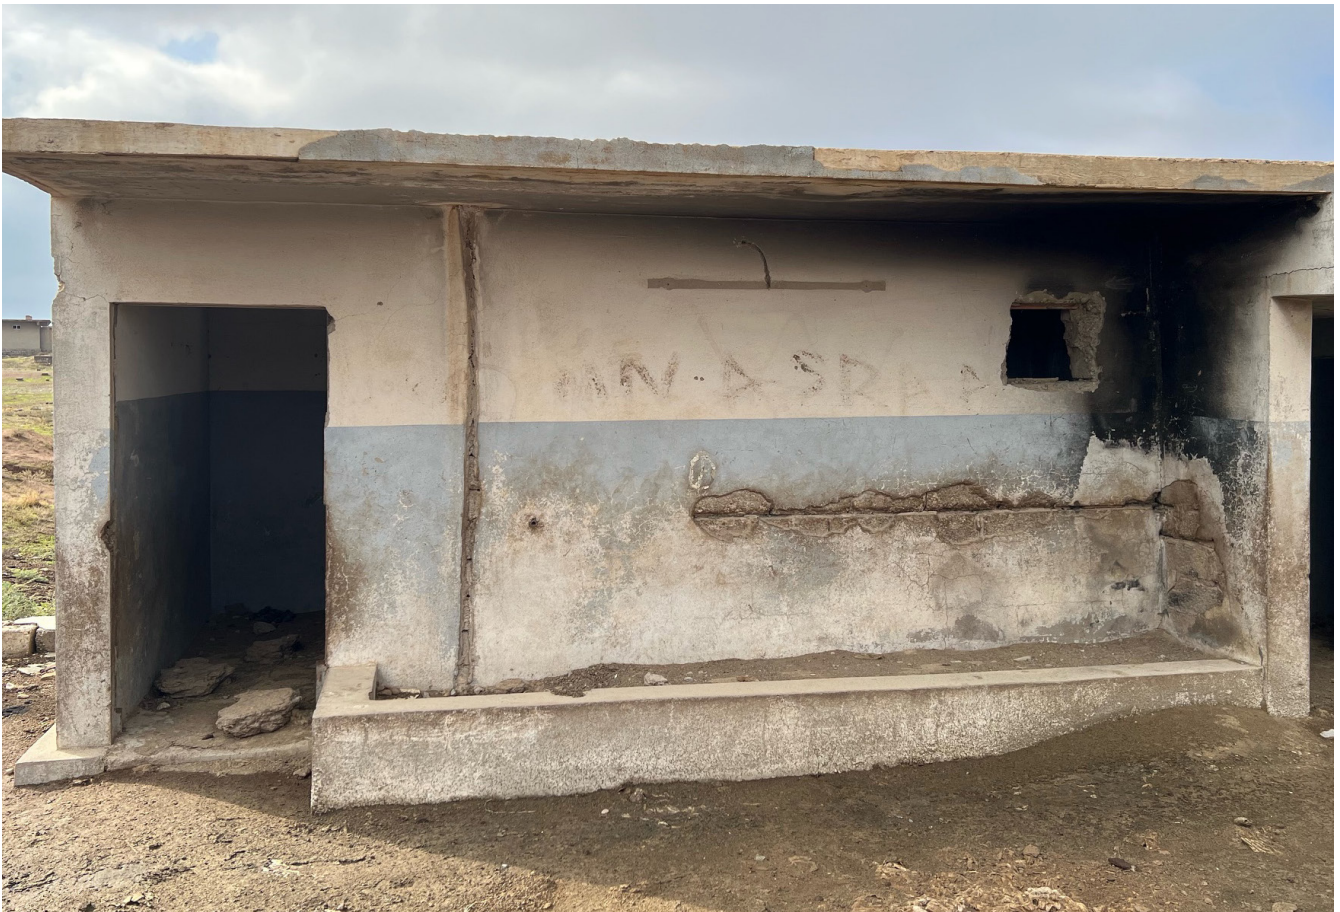
Figure 2: Small Shop in Aliyawa

There are four small shops owned by residents, however the products offered are limited. Families travel to larger markets outside the village, such as Hasansham Camp, Hamdaniya centre, and Kalak to purchase most household goods. KIs note that essential services like water and electricity, which are integral for business ventures, are limited. Agriculture and public employment are the primary sources of income. Families also rely on daily labour. Addressing infrastructure and service gaps would help to create a conducive environment for businesses and foster economic sustainability.

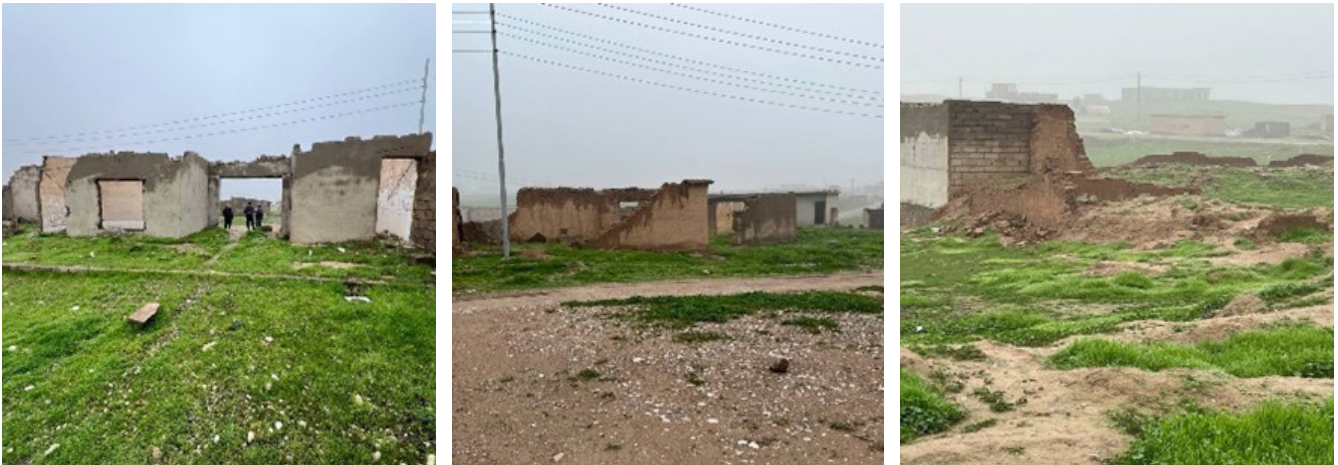
Figure 4: Mangoba Destroyed Housing

KIIs estimate that 210 houses are either destroyed or damaged.<sup>8</sup> Among them, approximately 130 residences have undergone complete destruction, while an additional 80 houses face varying degrees of damage or partial destruction, including instances of burning. At present, no debris removal initiatives have been set into motion. Some families have taken the initiative to commence the rehabilitation of their houses. During this rehabilitation phase, they continue to reside in the same damaged dwellings. Fortunately, construction materials necessary for rehabilitation are readily available in the area, including cement blocks, mud blocks, sand, gravel, and iron. This accessibility to construction materials is anticipated to facilitate the reconstruction efforts undertaken by affected families.

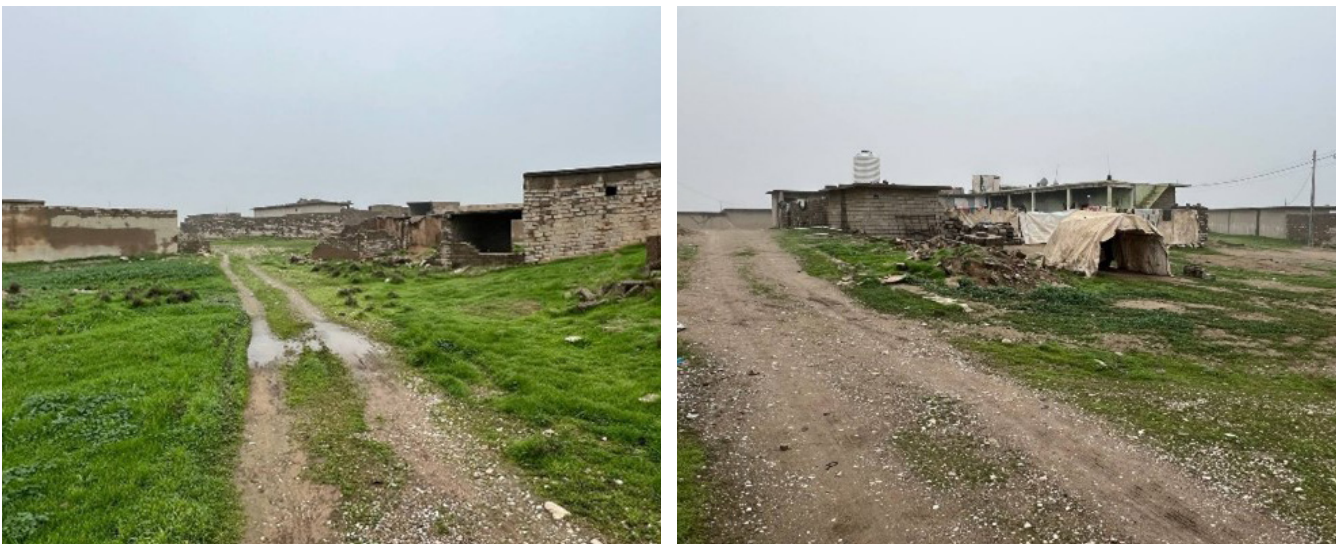
Figure 5: Mangoba Unpaved External and Internal Roads

The roads are unpaved and cause significant challenges to villagers, especially during the winter. The lack of drainage systems along roads and pathways poses a challenge. Households currently use cars, taxis, motorcycles/bicycles, and walking to get around.

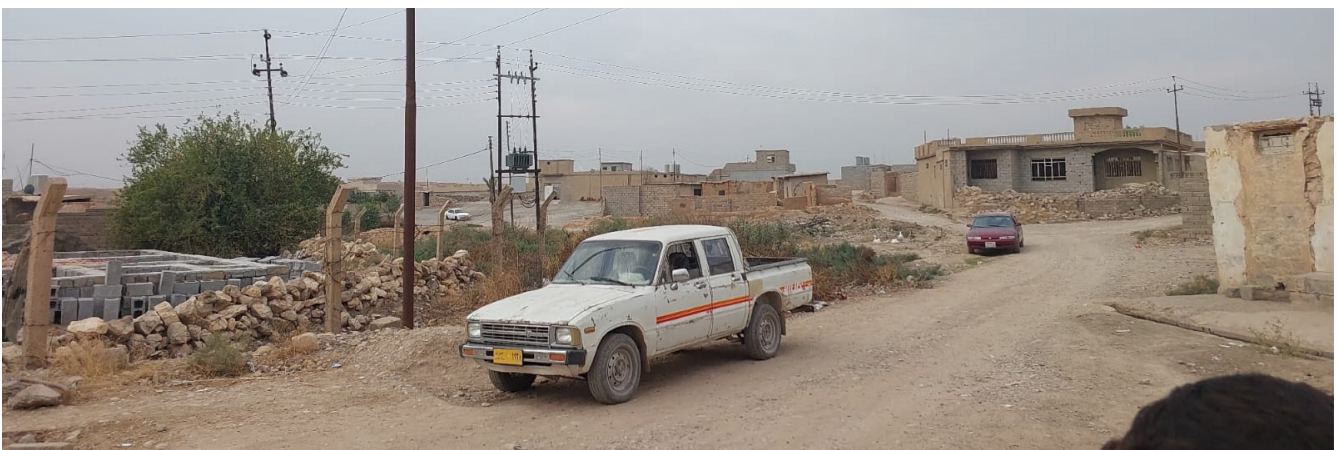
Figure 6: Shirkan Village Electricity Network Cable, Poles, and Internal Road

The community currently lacks a centralized electricity source, and families rely on private generators. Some households, however, have limited access to a public network, providing electricity for 8 to 10 hours per day. The absence of poles, electricity networks, and transformers is notable, as these infrastructures were damaged during the period of ISIS conflict.

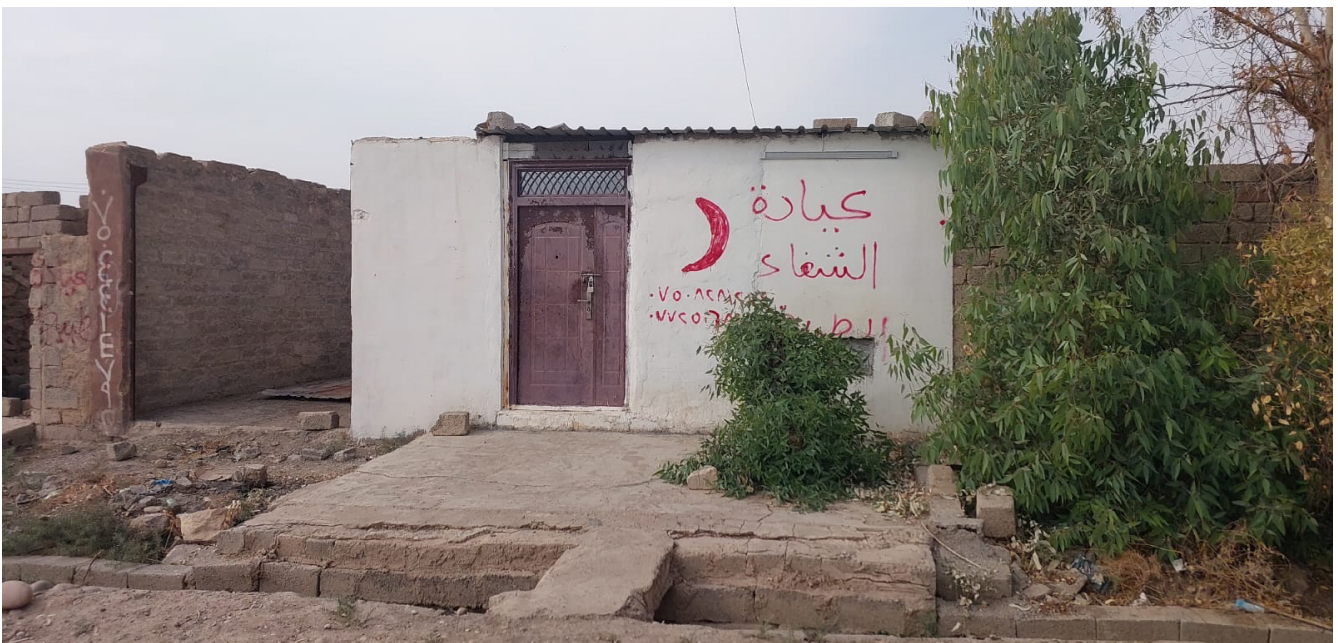
Figure 7: Small Private Clinic in Shirkan Village

The village has never had a PHC. Families access primary health care services in Kalak, Hamdaniya, or Bartella. A private clinic with a resident doctor is available in the village to address healthcare requirements. For more serious conditions, residents travel to the locations mentioned earlier.

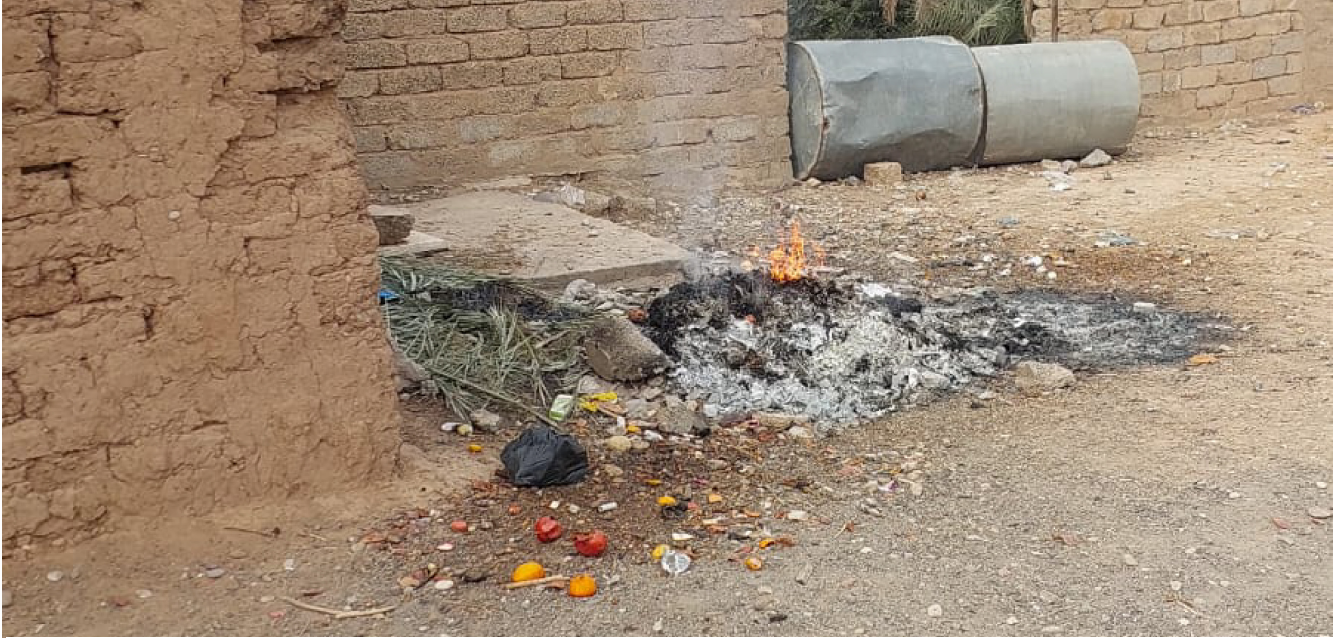
Figure 8: Shirkan Garbage Burning

Solid waste is managed by burning rubbish, both within and outside the community. No landfill or sewage system is available.

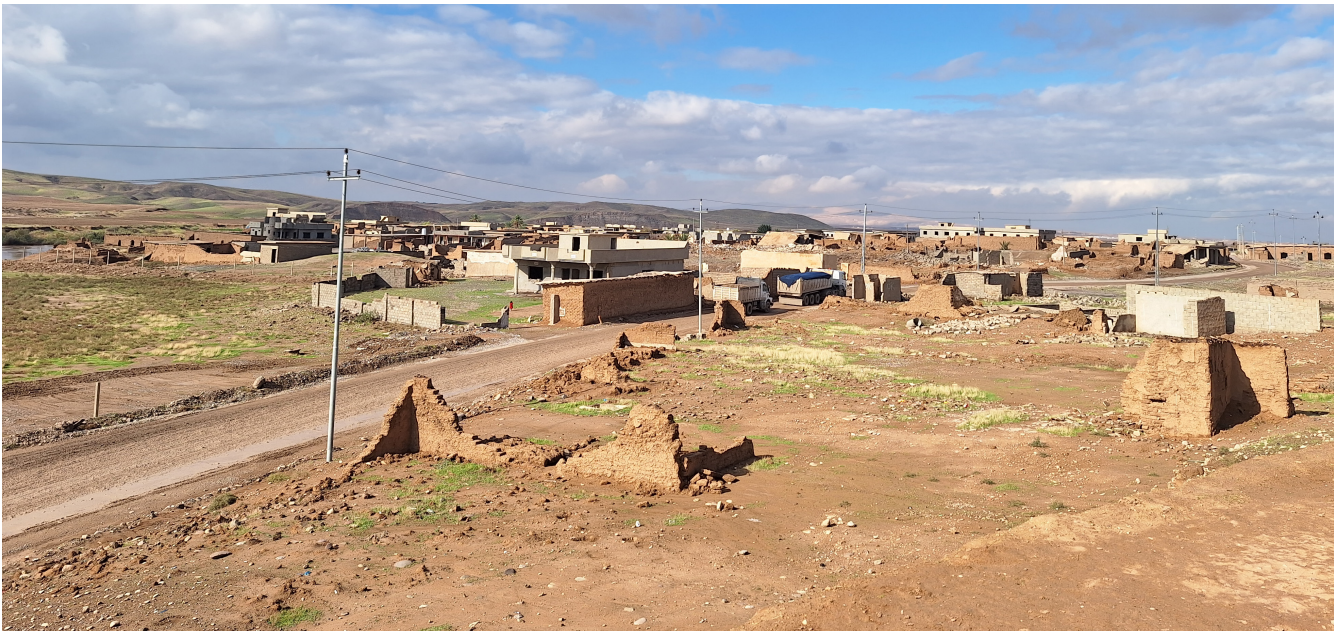
Figure 9: Chamakor Village Electricity Poles on Main Road Not Connected to Village

Prior to the conflict, the village was connected to the public electrical network. There are visible installed poles and electrical wires in the main road of the village, and households reported that these are to feed Telleben while residents in Chamakor are not allowed to access the network. Internal electric poles, wires, and transformers were looted during and after the conflict. Returnee households use private generators as the main source of electricity, and solar lights brought from the camp or bought for IQD15,000 for lighting. Private generators are run from 30 minutes to one hour daily to fulfil the households' basic needs.<sup>17</sup>

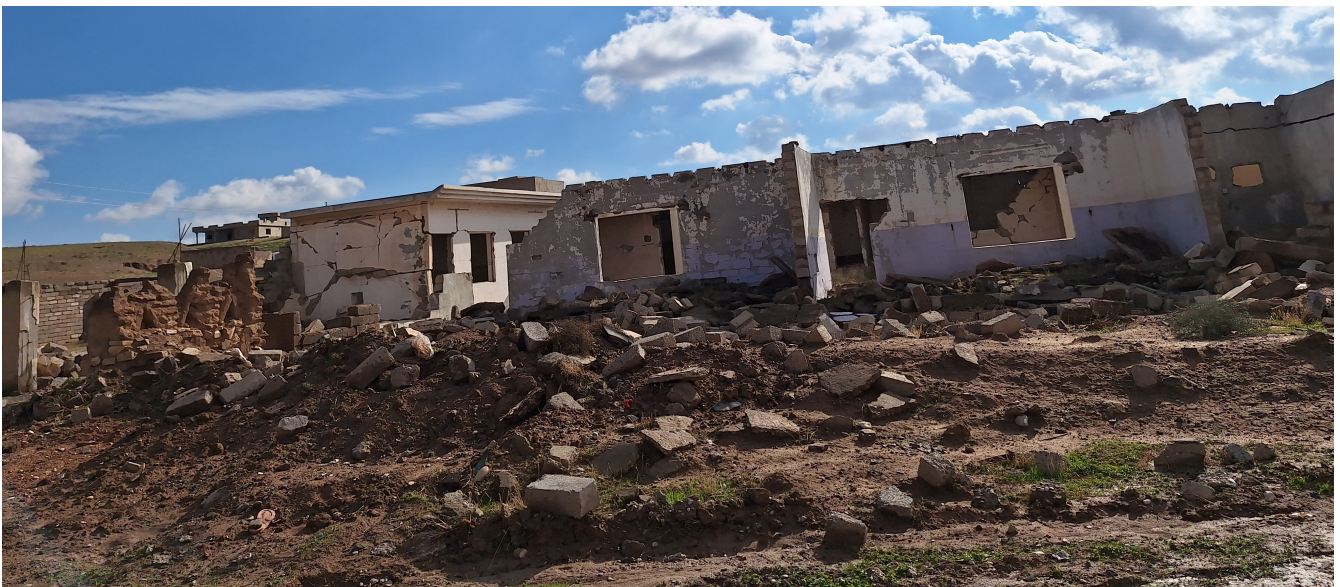
Figure 10: Chamakor Damaged Houses

Most houses in the villages require rehabilitation, as nearly all houses are damaged or looted. According to the Hamdaniya authorities' assessment conducted in 2021, 80 houses are destroyed (out of 120 housing units).<sup>19</sup> No general efforts to remove the debris were reported.

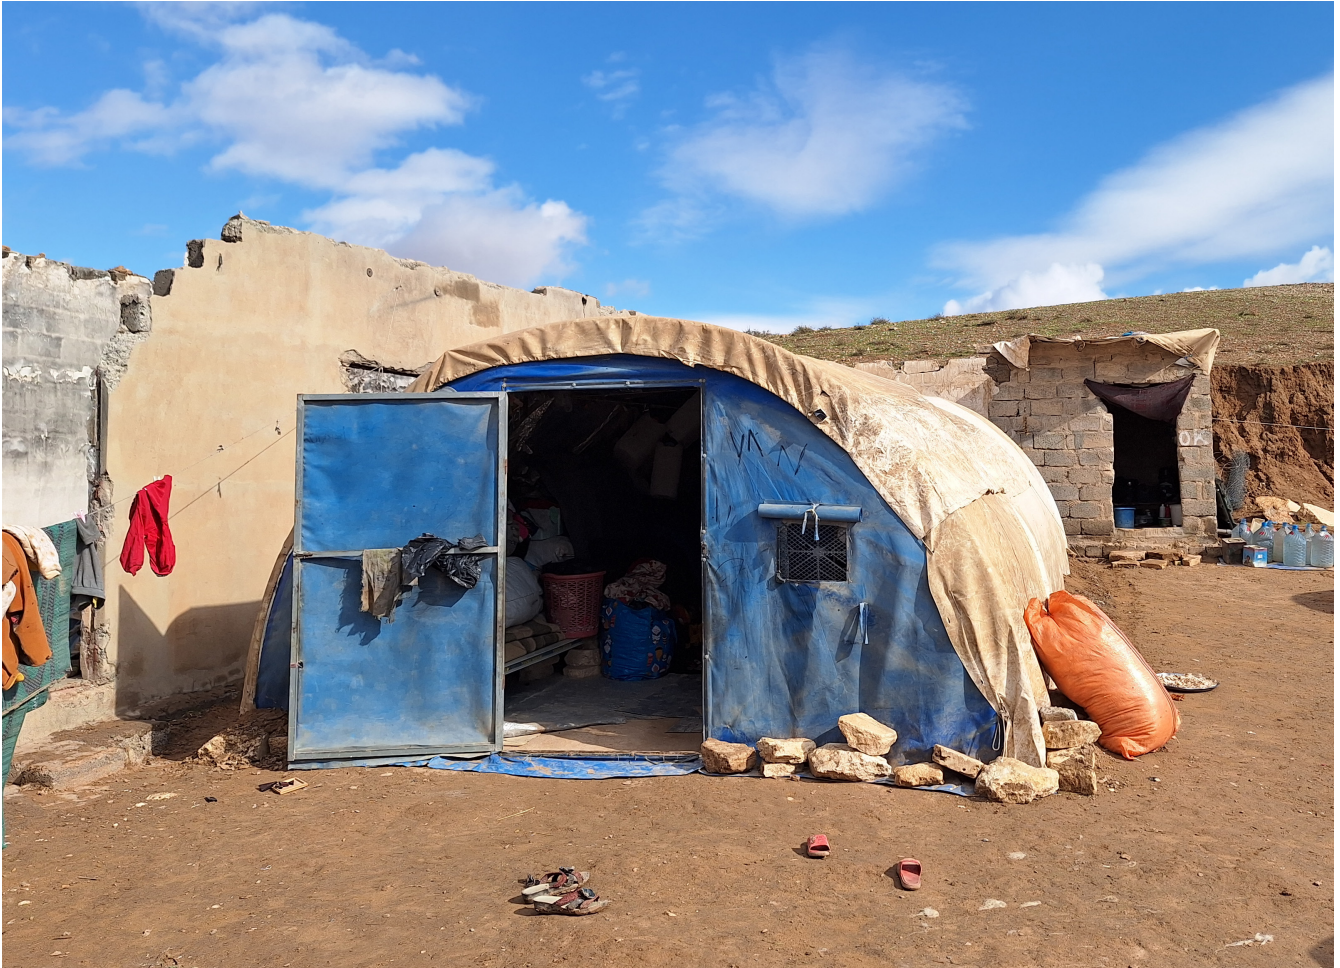
Figure 11: Chamakor Recent Returnee Household Tent Shelter

Returnee households removed, and are still removing, the debris from their houses on their own efforts. Returnee households reside in a housing compound belonging to the mukhtar (6 households) and other two, both female-headed households, reside in tents as temporary shelters until their houses are rehabilitated. Construction materials such as concrete blocks, cement, iron, etc. are widely available in Kalak but at high prices.<sup>20</sup> Households with lower financial means use mud and other low-cost materials for their house's rehabilitation and construction.

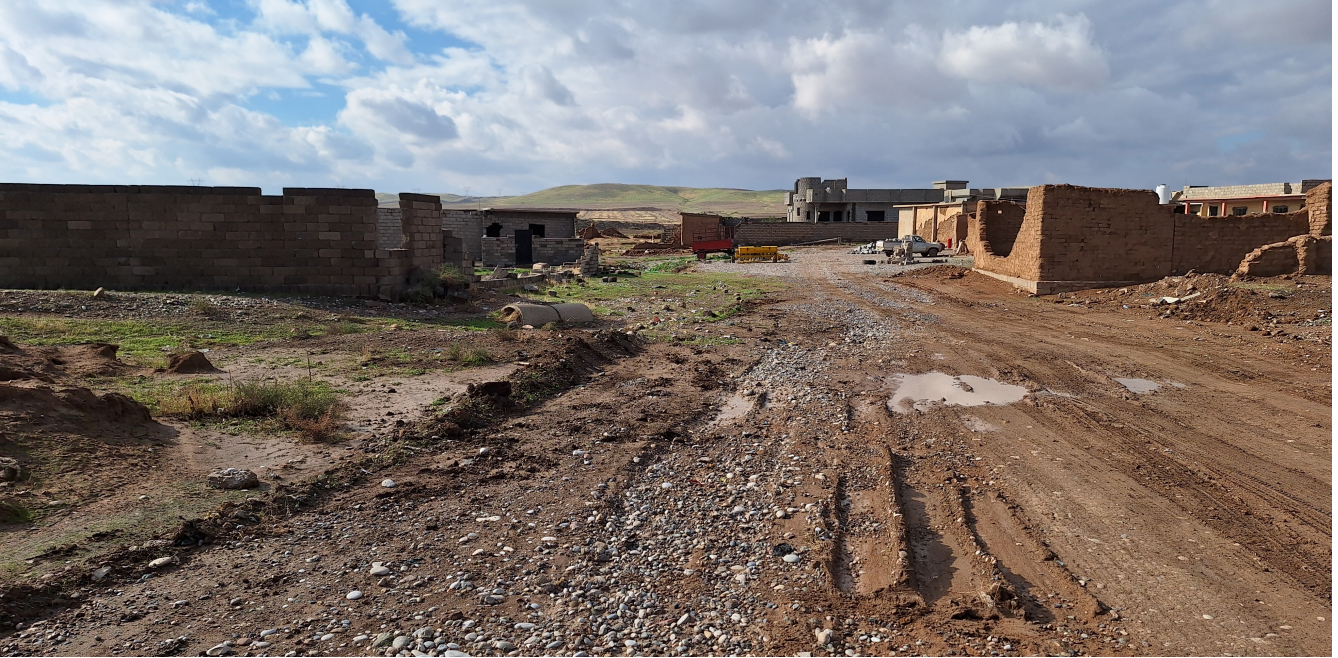
Figure 12: Chamakor Unpaved Internal Road

The main road to access the village is not paved and it creates access issues within the community.

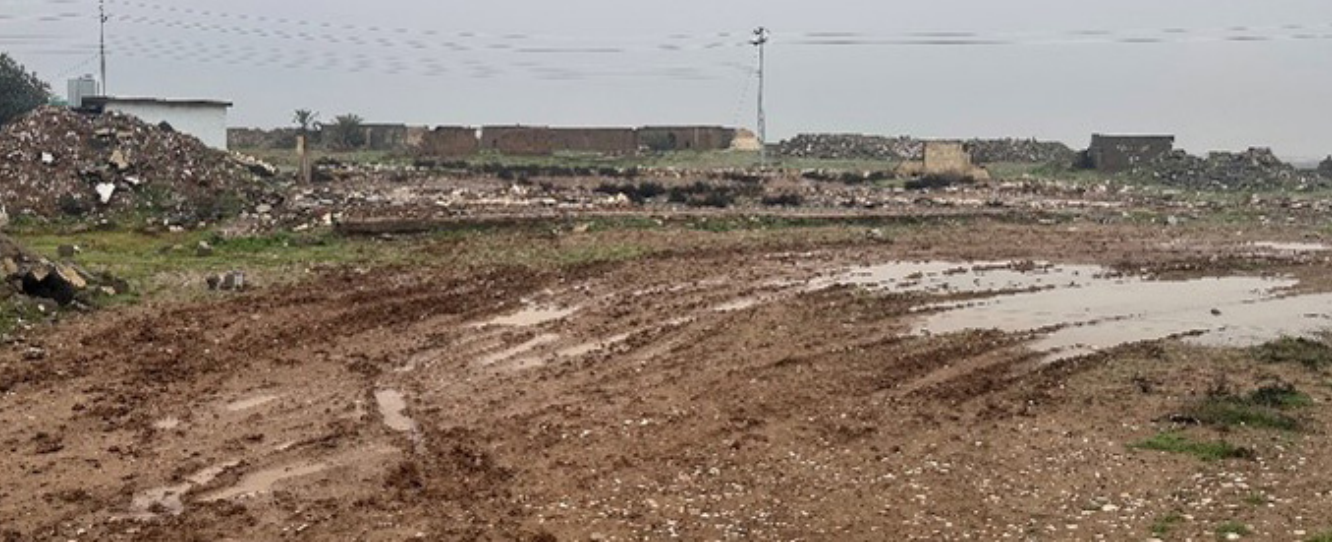
Figure 13: Destroyed School in Tal Aswad Kabir

One primary school (Tal Aswad Kabir Primary School) was available in the village, but it is heavily damaged. Prior to the conflict, teachers used to come from Mosul city. Around 200 children dropped out from school due to the lack of financial means to cover transportation to schools (10 kilometres far from the village). These schools cannot accommodate the students from Tal Aswad Kabir since they are crowded and partially destroyed. The closest school to the village is in Khazir camp (1 kilometre away). UNDP estimates that it would cost \$250,000 to rehabilitate the 6-classroom mixed primary school.

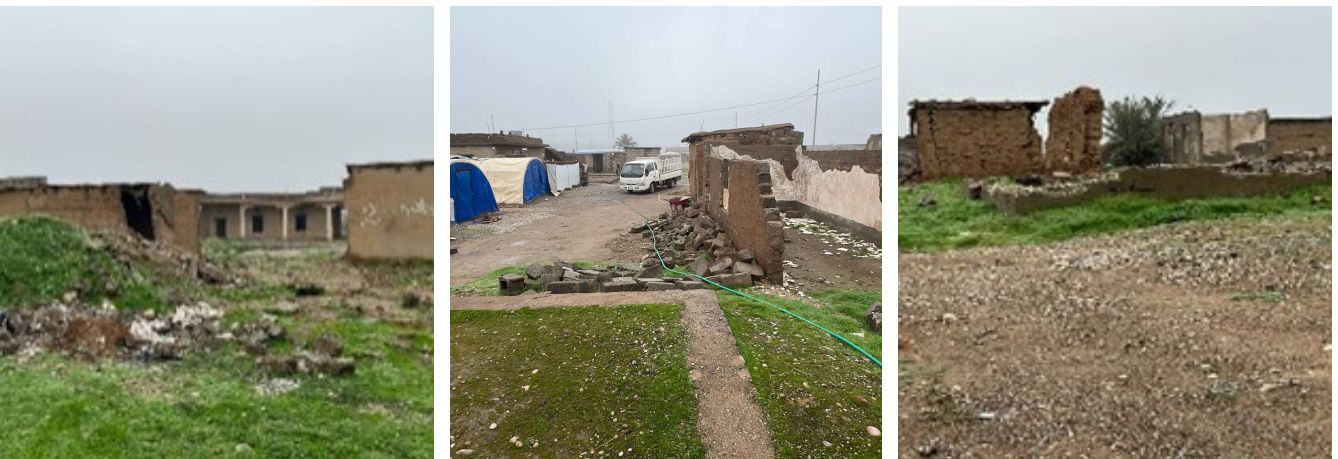
Figure 14: Destroyed Housing and Current Shelter in Tal Aswad Kabir

Most houses in the villages require rehabilitation as nearly all houses are heavily damaged or destroyed. UNDP estimates that the village had 85 houses and 90% are totally damaged. Returnee households reside in tents brought from the camp as temporary shelters while they rehabilitate their houses. Construction materials such as concrete blocks, cement, sand, gravel, gypsum, etc. are not widely available in the area.

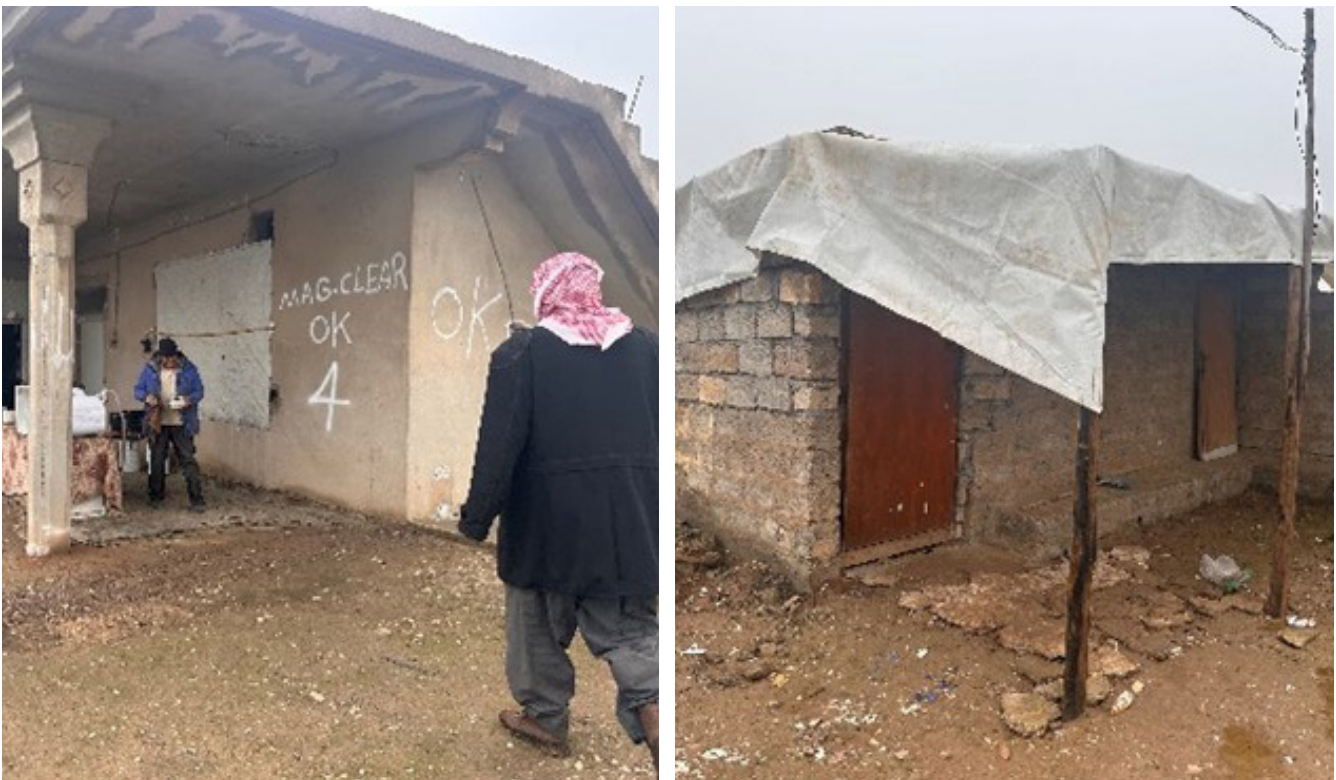
Figure 15: Small Store in Tal Aswad Kabir

There are limited shops or industrial facilities or service providers for improving (self)-employment skills available in the village. The key challenges facing existing businesses in the area included the lack of vocational skills, lack of financial means to start over new businesses, lack of raw materials, and the distance from the big cities where these items can be found.

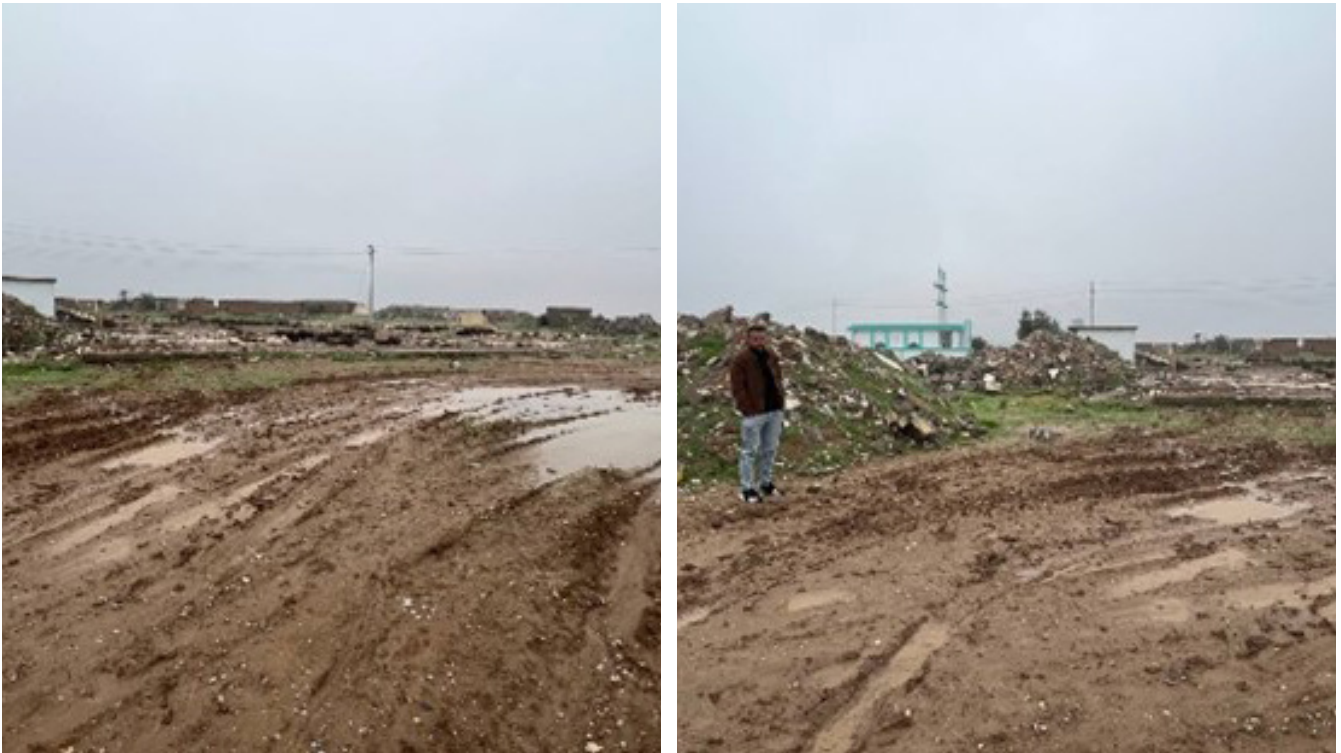
Figure 16: Unpaved External Road in Tal Aswad Kabir

The main road to access the village is not paved, and the pathways are currently under demining. Households are facing difficulties when it rains due to the lack of a draining system in the village which threatens the tents with flooding. Prior to the conflict, residents used a variety of transportation means including private cars, taxis, motorcycles, and bicycles, and walking when feasible. After the conflict, returnee households depended on private cars or walking.

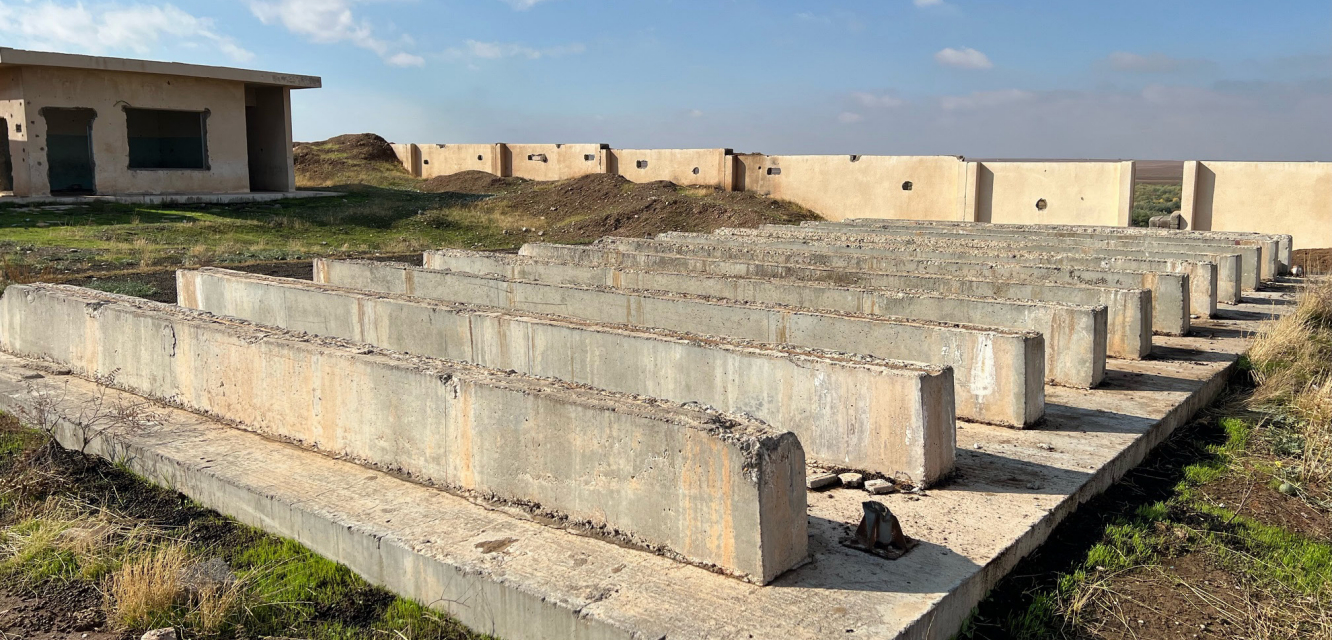
Figure 17: Tal Aswad Saghir Damaged Water Treatment Plant

Additionally, households reported using collected water from the river pumped into the lands to feed agricultural fields and livestock. There is no sewage system in the village. A comprehensive assessment conducted by UNICEF indicates the need for pumps, water tanks, filtering units, a generator, water quality testing equipment and personnel to manage the WTP.<sup>24</sup>

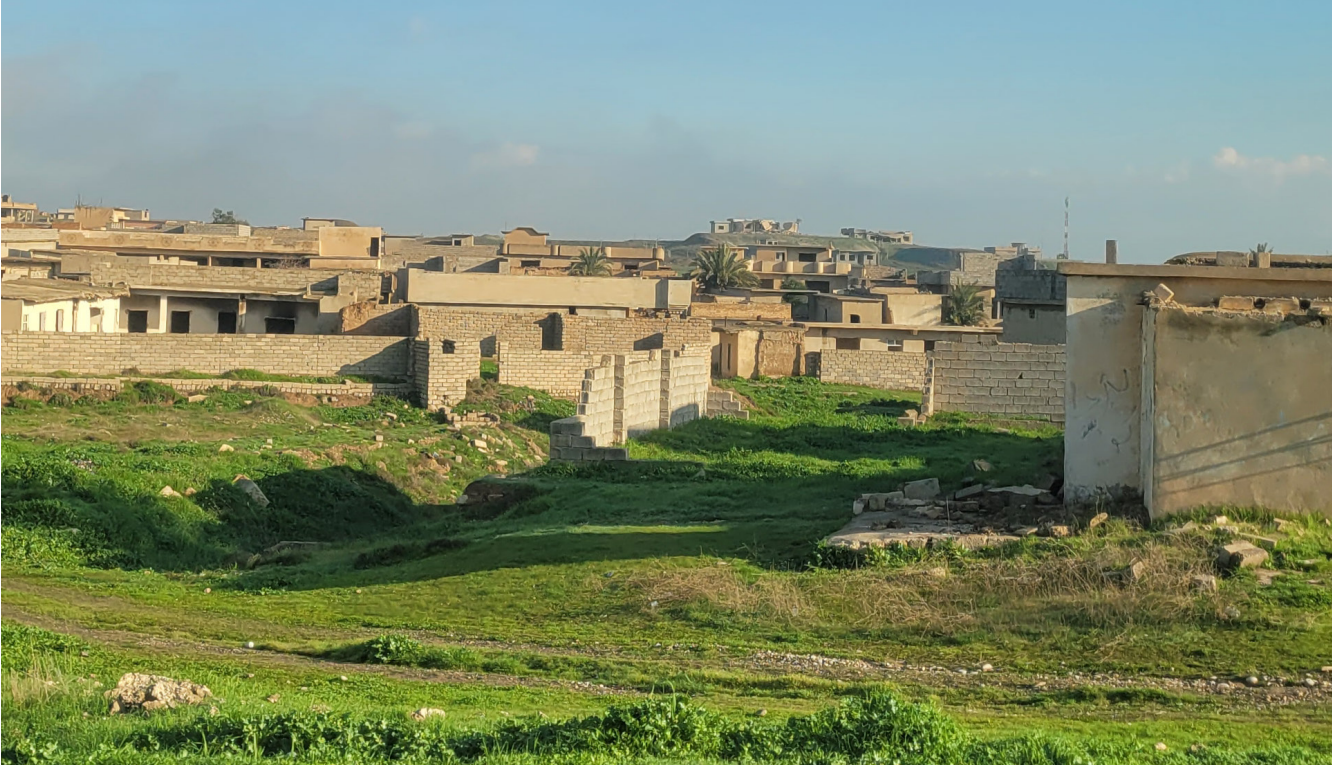
Figure 19: Hasansham Village

The entire village is displaced and currently families are in the East Mosul Camps, Erbil and in Mosul. Of the 12 villages, this village has the largest number of families who are currently in the East Mosul Camps. Inferences have been made that despite the July announcement which approved return to all the 12 villages, families from this village might not be allowed to return.

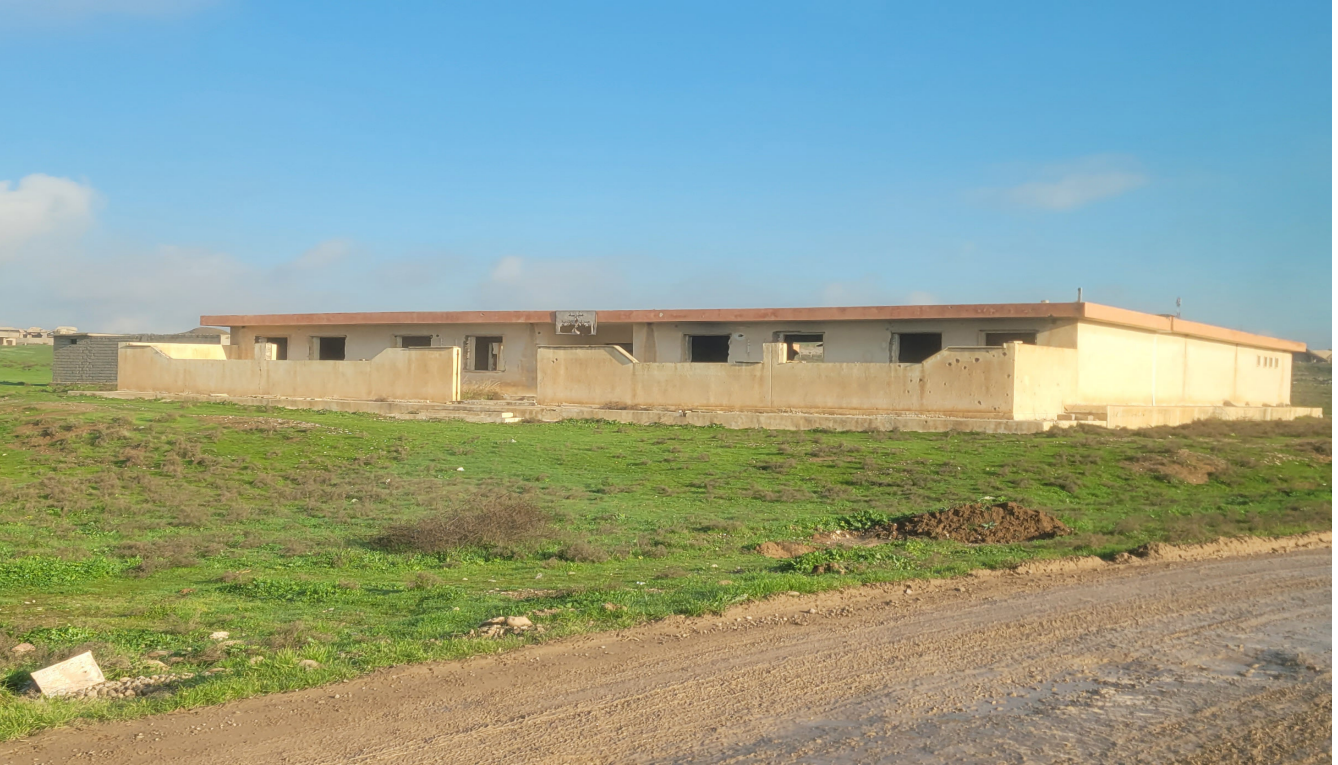
Figure 20: Hasansham Village Primary School with Minor Damage

According to the government the village had 3 schools, Hasansham Primary School for Boys, Hasansham Primary School for Girls and Hasansham Secondary School. One of the primary schools incurred minor damage to 7 rooms, the cost of which is estimated to be \$65,000. The Secondary School which also served the surrounding villages is destroyed.
